Manhole Inspection Summary

Manhole # S27CC_018MH

Insp Date: **11/15/07 4:04 PM**

Location Address: **ARGYLE AVE**

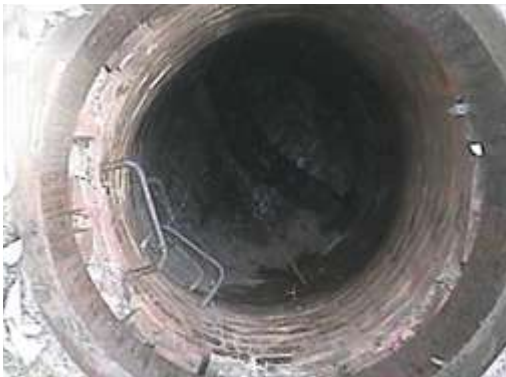
Defect 1

Steps Count: **6** Missing: **0** ☒ **Corroded**

STEPS CORRODED

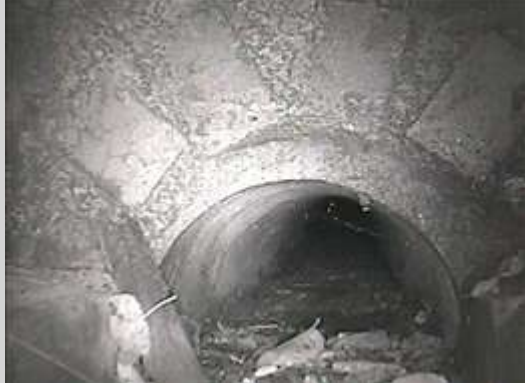
12 O'Clock Outflow

Pipe Height: (in.) Direct
Pipe Material: **Clay** ☐ Pipe Lined
Invert Depth: **8.85** (ft.) Flow Characteristics: **Slow**
Deposits: ☐ None ☐ **Mud** ☐ Sludge ☒ **Debris** ☐ Grease
Silt Depth: **2** (in.) Deposits Extent: **Light**
Infiltration: **None** Pipe Seal Cond: **Sound**

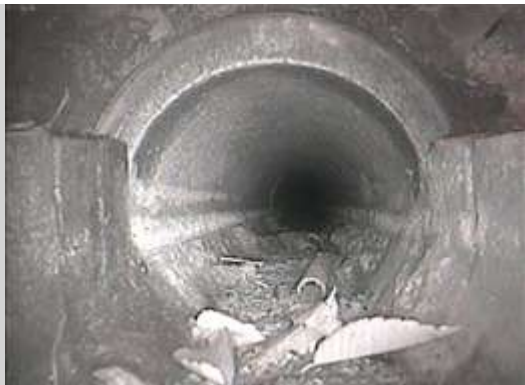
5 O'Clock Inflow

Pipe Height: (in.) Direct
Pipe Material: **Clay** ☐ Pipe Lined
Invert Depth: **8.75** (ft.) Flow Characteristics: **Slow**
Deposits: ☐ None ☒ **Mud** ☐ Sludge ☒ **Debris** ☐ Grease
Silt Depth: **4** (in.) Deposits Extent: **Medium**
Infiltration: **None** Pipe Seal Cond: **Sound**
